# Manhole Inspection Summary

Manhole # S41WW\_003MH

Insp Date: **4/3/07 9:23 AM**

**Location** Address: **3220 LOCH RAVEN BLVD** Cross Street: **GORSUCH AVE**

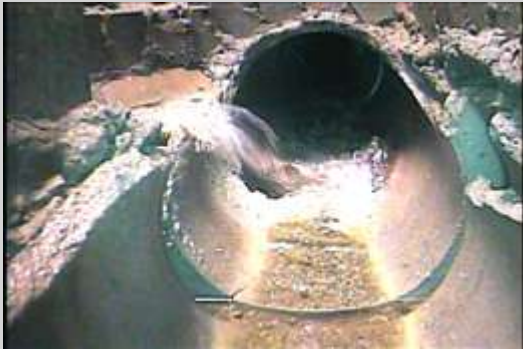
### 10 in. Circular Gravity Sewer Pipe Out @ 12 O'Clock

Pipe Material: **Clay** ☐ Pipe Lined

Invert Depth: **10.45** (ft.) Flow Characteristics: **Slow**

Infiltration: **None** Pipe Seal Cond: **Unknown**

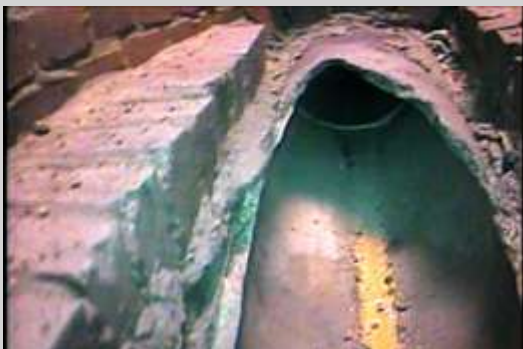
### 10 in. Circular Gravity Sewer Pipe In @ 6 O'Clock

Pipe Material: **Clay** ☐ Pipe Lined

Invert Depth: **10.10** (ft.) Flow Characteristics: **None**

Infiltration: **None** Pipe Seal Cond: **Unknown**

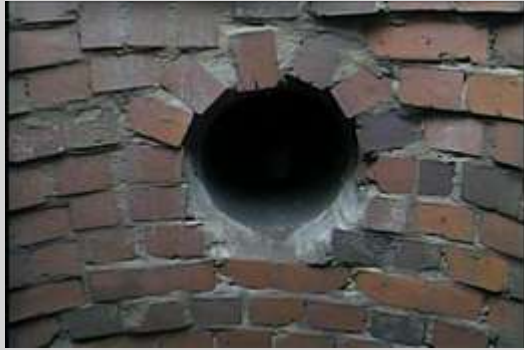
Pipe In @ 8 O'Clock

Pipe Material: **Clay** ☐ Pipe Lined

Infiltration: **None** Pipe Seal Cond: **Unknown**

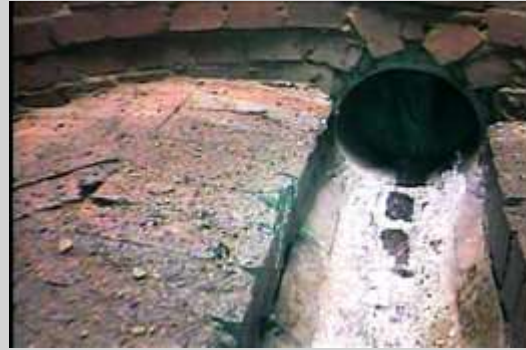
Drop In @ 8 O'Clock

Drop Condition: **Open**
